# Manhole Inspection Summary

Manhole # S07AA2020MH

**Location** Address: **2700 CROSS COUNTRY BLVD**

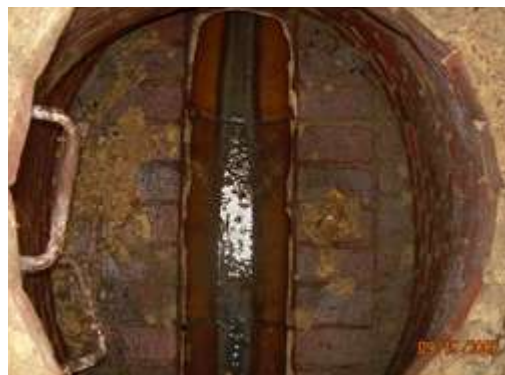
Top View

Adjustment and Corbel infiltration.  
Evidence of surcharge - Bench debris.  
Corroded steps.

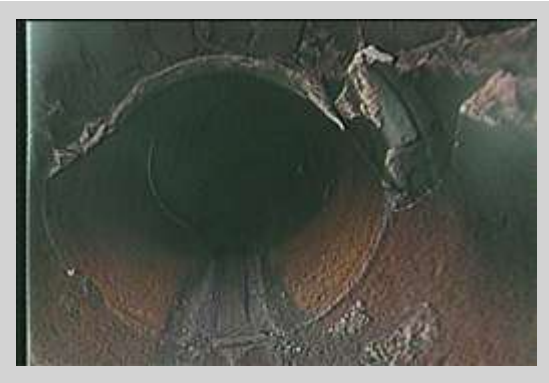
### 12 in. Circular Gravity Sewer Pipe Out @ 12 O'Clock

Channel cracks.

Infiltration: **Evidence** Pipe Seal Cond: **Broken**

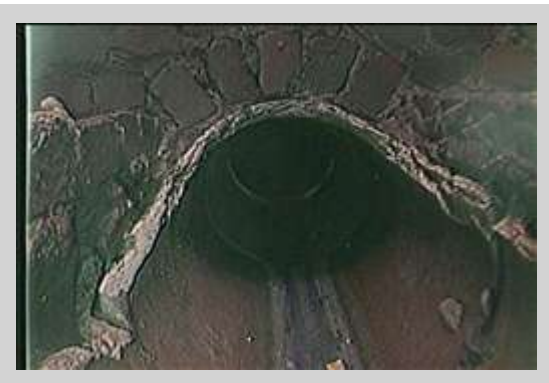
### 12 in. Circular Gravity Sewer Pipe In @ 6 O'Clock

Barrel deterioration and infiltration. Channel deterioration and cracks.

Infiltration: **Evidence** Pipe Seal Cond: **Cracked**
